IN-SITU MONITORING OF TEMPERATURE AND RELATIVE HUMIDITY FIELDS IN A HISTORICAL BUILDING PROVIDED WITH ADDITIONAL THERMAL INSULATION

Jan Toman, Robert Černý

Czech Technical University in Prague, Faculty of Civil Engineering, Department of Materials Engineering and Chemistry, Thákurova 7, 166 29 Prague 6, Czech Republic, email: toman@fsv.cvut.cz, cernyr@fsv.cvut.cz

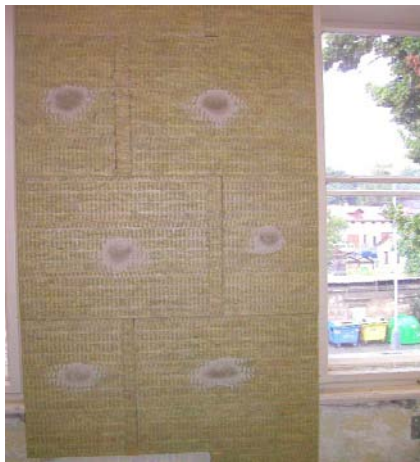
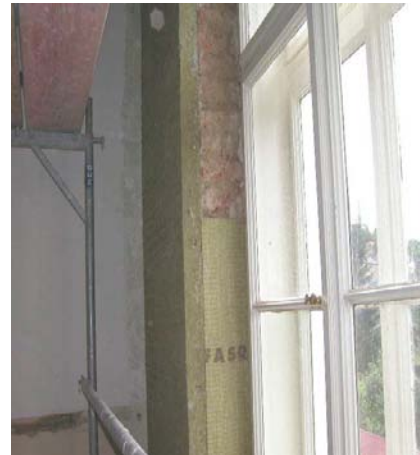
were then painted with two coats of paint. The facing of the wooden walls was fixed on the supporting structure made from lathes. These lathes created the space for ventilation between the thermal insulating surface and the facing of the wooden walls. Gummy foam was used for mounting the frame of the wooden wall facing on the insulating layer. The technology of work and constructive details are demonstrated in Figures 1a, b.

Figures 1a, b Selected constructive details

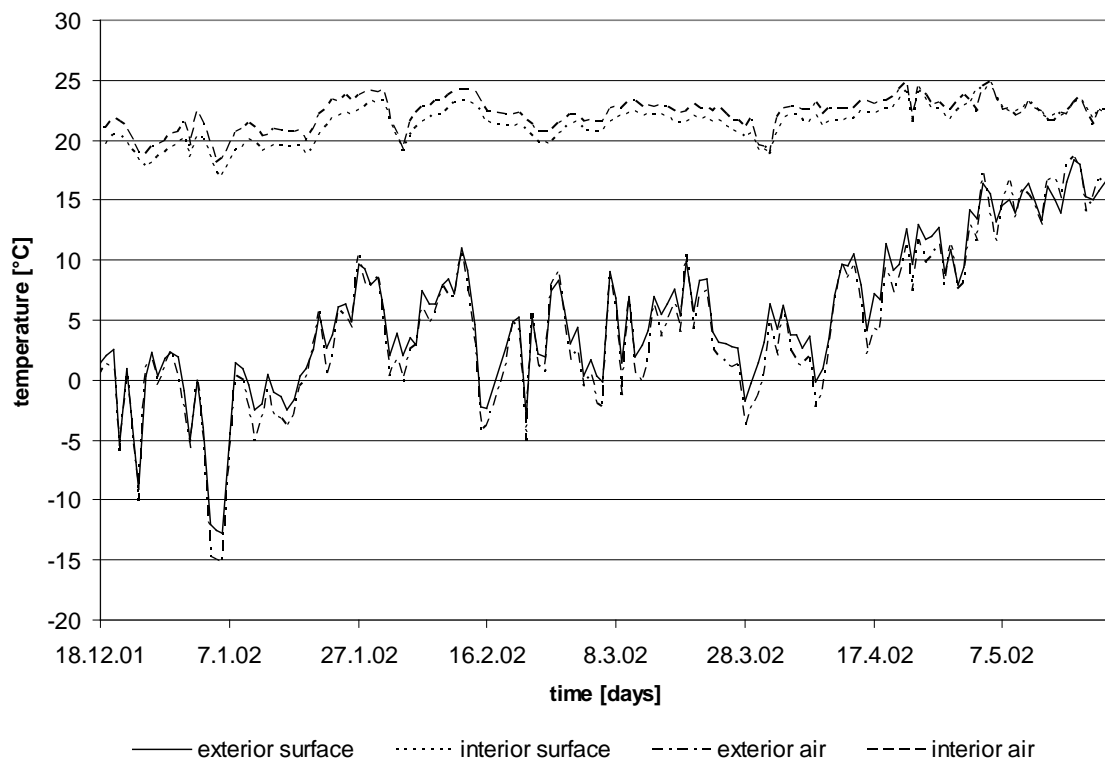
Figs. 2, 3 show time development of temperatures and relative humidities in the east wall during the last winter before the reconstruction, Figs. 4, 5 during the second winter after reconstruction.

A comparison of temperatures in Figs. 2, 4 shows the positive thermal qualities of the applied interior thermal insulation system. The most substantial temperature changes occurred in the thermal insulation layer.

Figure 2 Time development of temperatures in the east wall during the last winter before the reconstruction

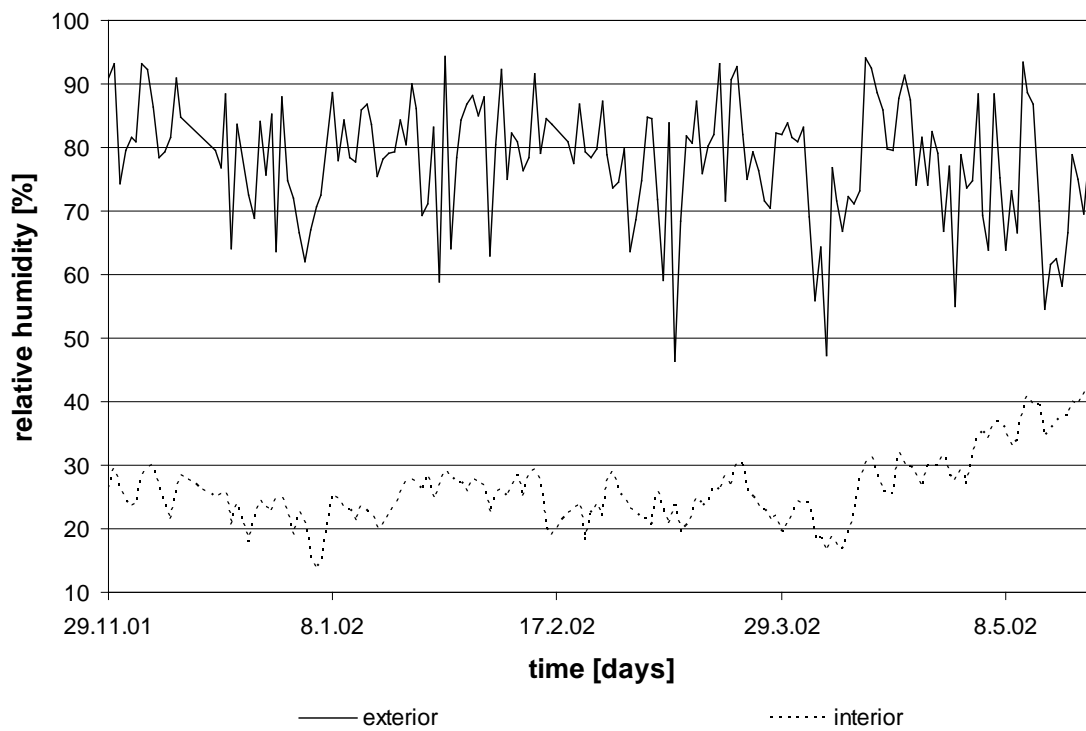
Figure 3 Time development of relative humidity in the east wall during the last winter before the reconstruction

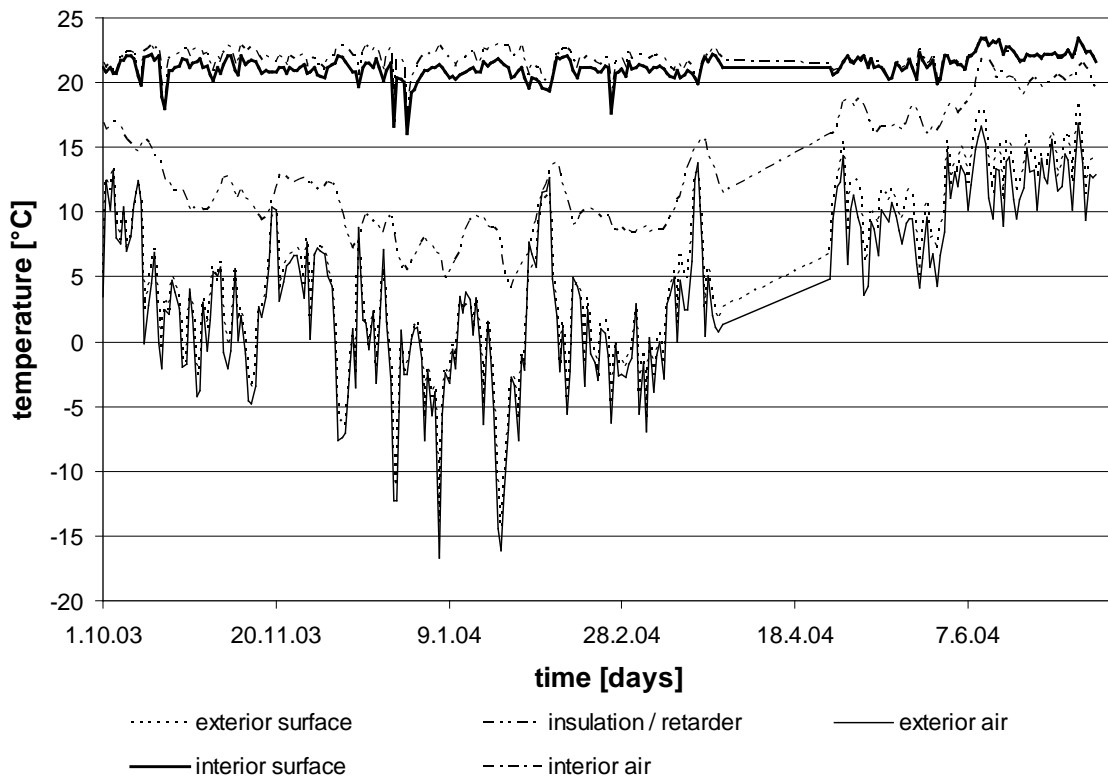
Figure 4 Time development of temperatures in the east wall during the second winter after reconstruction

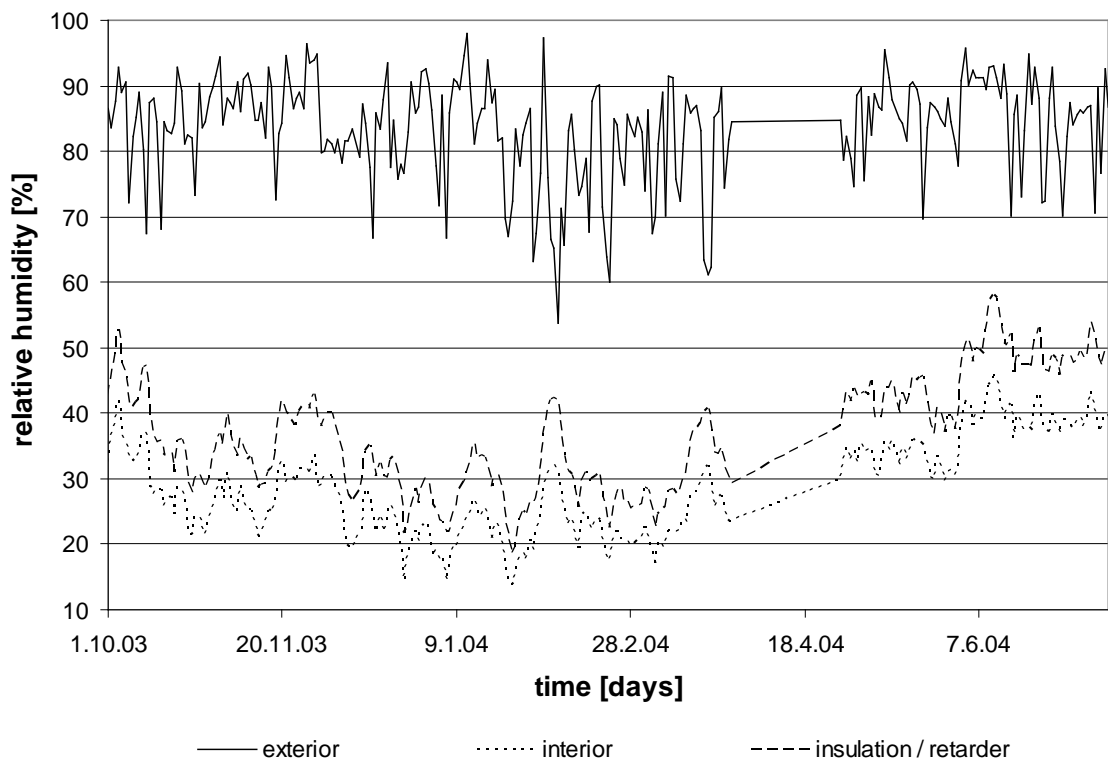
Figure 5 Time development of relative humidities in the east wall during the second winter after reconstruction

The hygric performance of the system was also found to be excellent. Fig. 5 shows that the maximum values of relative humidity on the surface of water vapor retarder, which is the critical point of the designed system, were in the winter period approximately 42%. This is very far from any condensation danger. The higher values of relative humidity in the beginning of the summer period (57%) were caused by a period of rain but the condensation was far from occurring either.
